# **Revision Guide for AMD Athlon™ 64 and AMD Opteron™ Processors**

Publication # <b>25759</b>	Revision: <b>3.51</b>
Issue Date: <b>May 2005</b>

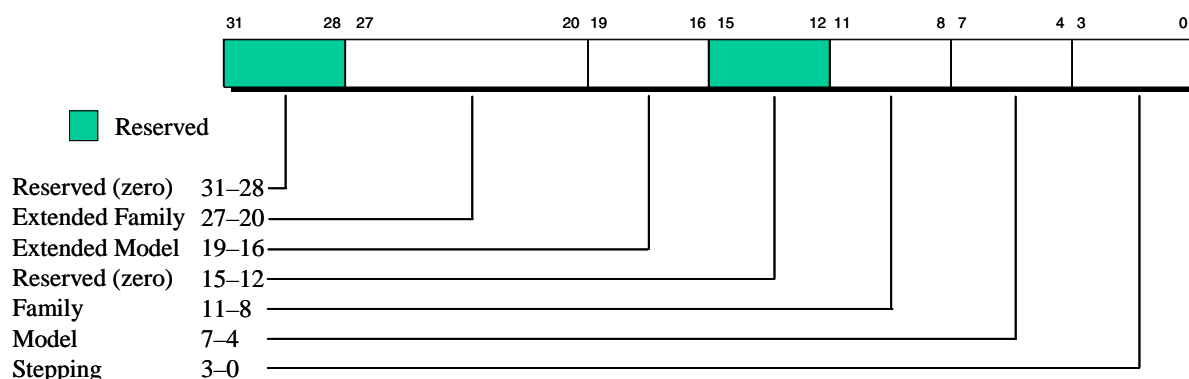
**Figure 1. Format of CPUID Value Returned by Function 1**

Figure 1 shows the format of the value returned in EAX by CPUID Function 1.
